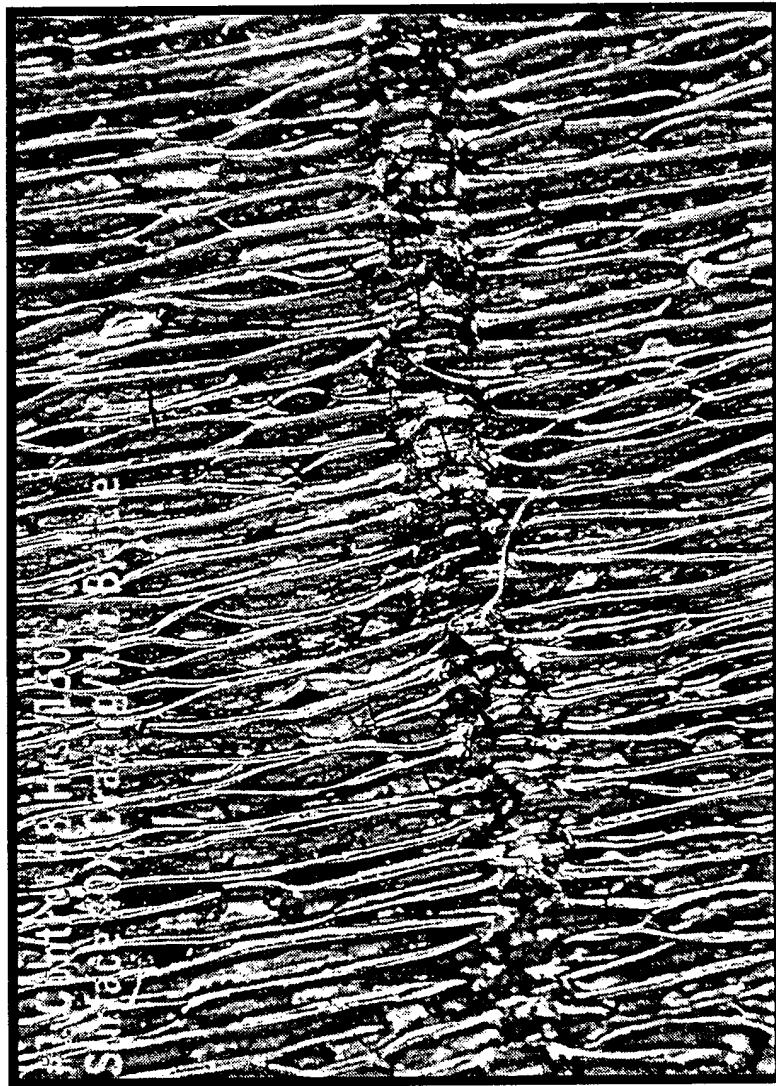
FIG. 1

Sample #1 Surface at 40X After
48 Hours at 150C

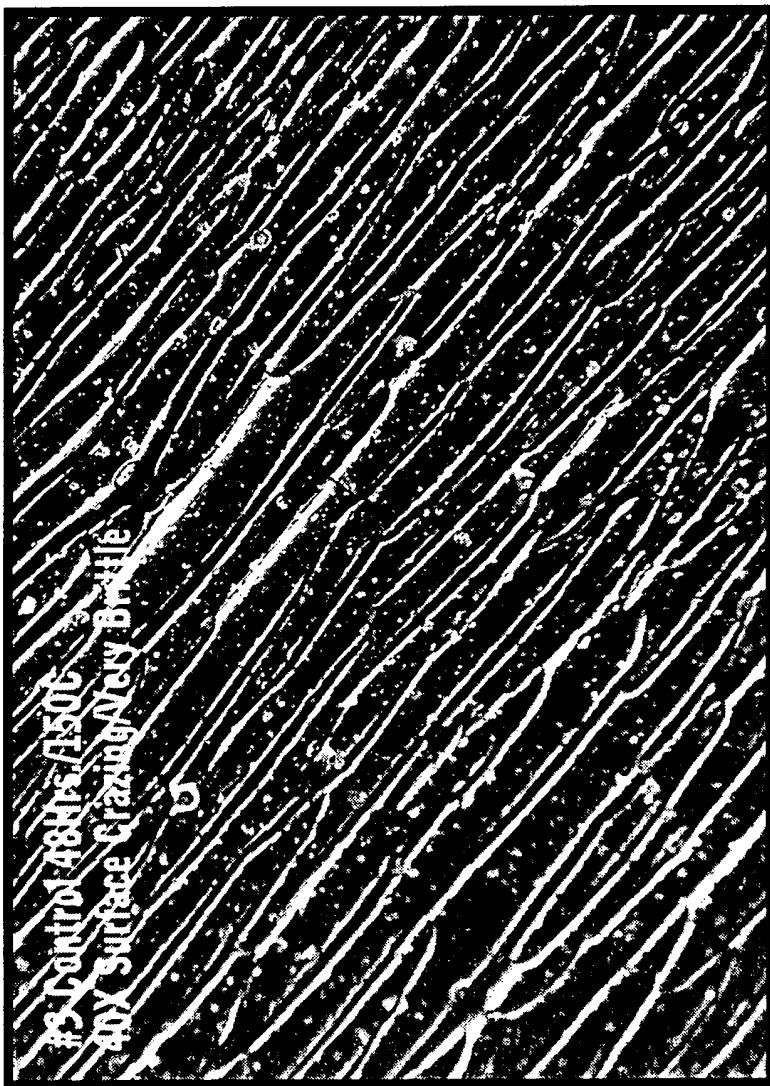
FIG. 2

Sample 3 Surface Photo 40X
After 49 hours at 150C

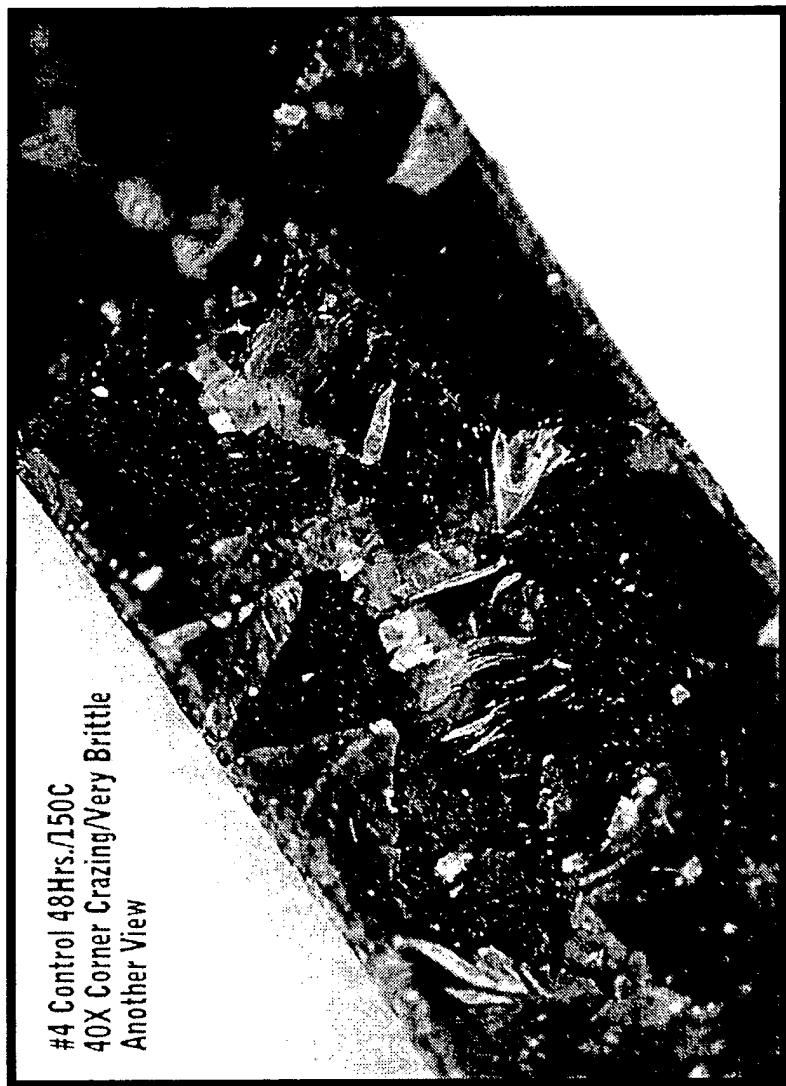
FIG. 4

Sample 4 Corner Shot 40X
48 Hours at 150C

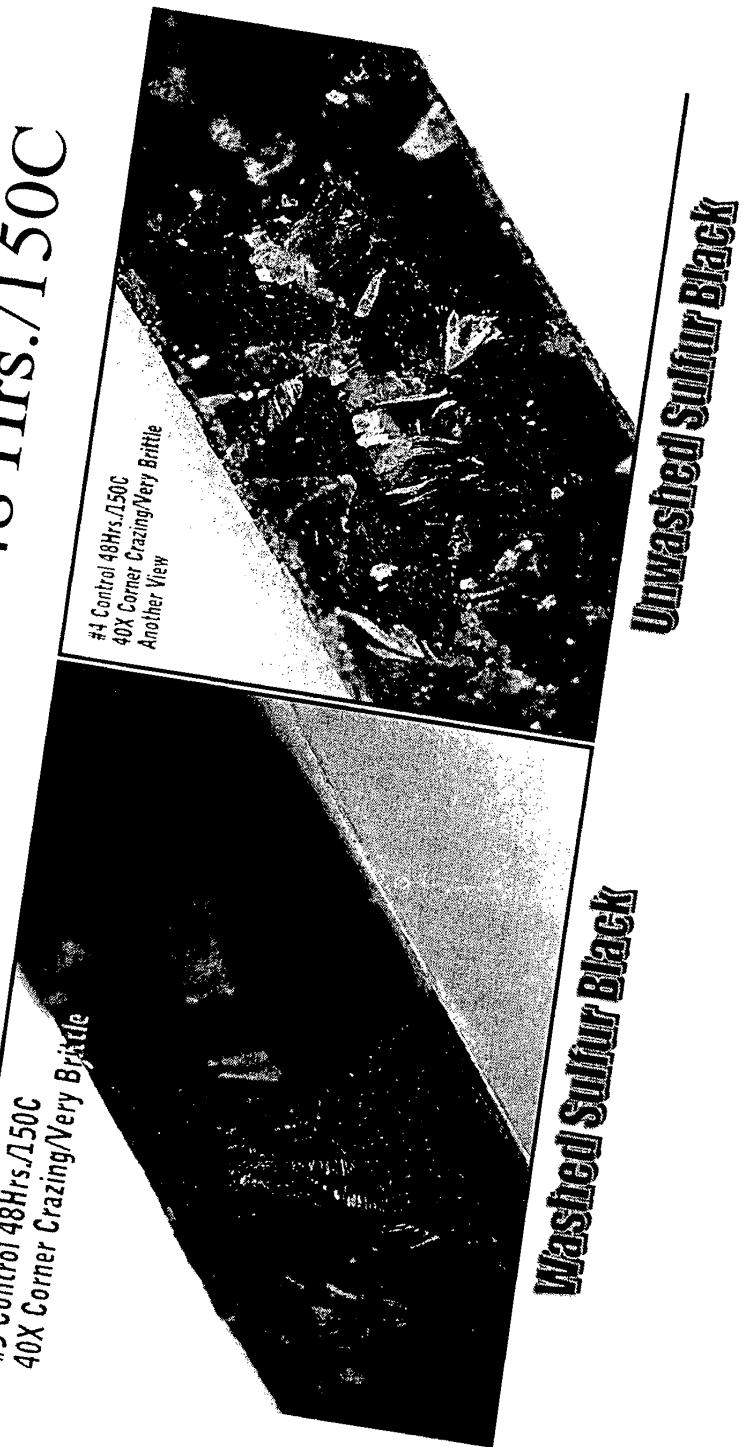
FIG. 6
Sample 3 versus 4
Corner View After 48 Hrs./150C

#3 Control 48Hrs./150C
40X Corner Crazing/Very Brittle

#4 Control 48Hrs./150C
40X Corner Crazing/Very Brittle
Another View
